Field Survey of Non-tectonic Surface Displacements Caused by the 2016 Kumamoto Earthquake Around Aso Valley

Takayuki NAKANO, Tomokazu KOBAYASHI, Kazuki YOSHIDA and Satoshi FUJIWARA

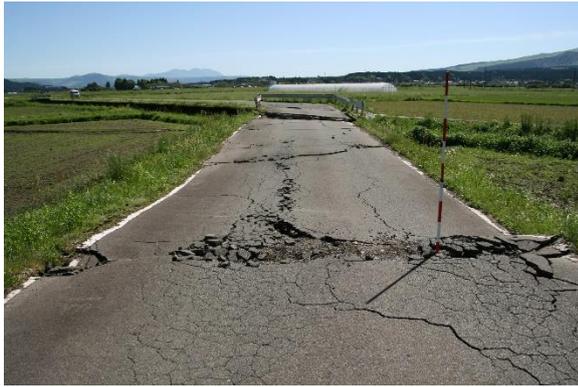
Figure 5 shows a close up figure of the Kurumagaeri area shown in the Figure 2. In this area, graben-like ruptures were confirmed along former river bed. Major ruptures cross a paddy field surface and a road, which matches the result of aerial photos interpretation (Photo 1), and the portion of the road between two ruptures subsided approximately 30 cm (Photo 2).

Photo 1 Graben-like ruptures along former river bed in Kurumagaeri area (taken towards the northeast on May 11, 2016)

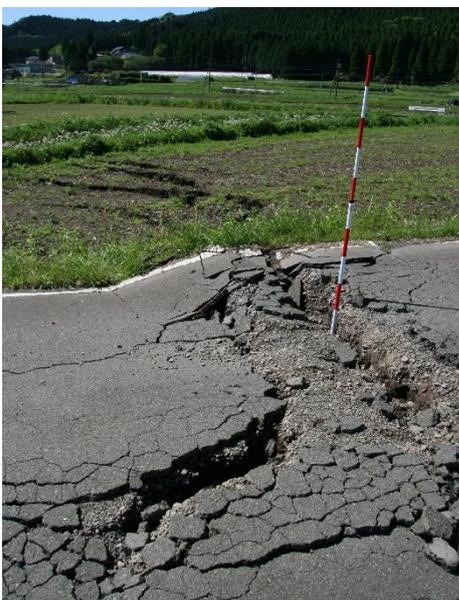
Photo 2 Western edge of graben-like ruptures along former river bed in the Kurumagaeri area (taken towards the south on May 11, 2016)

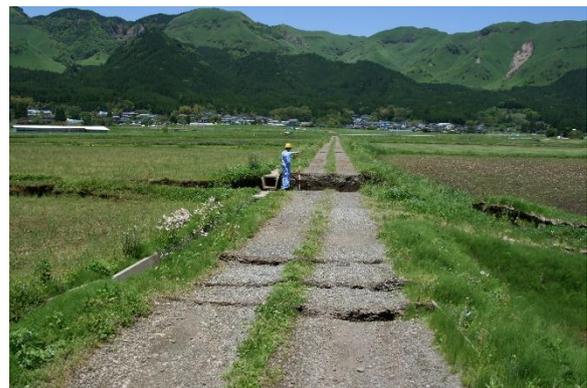
Figure 6 shows a close up image of the Matoishi area as shown in the Figure 3. At spots with graben-like ruptures located along the southern edge of the horizontal displacement areas as detected by SAR interferogram, there were open cracks with vertical offsets of up to 70 cm (Photos 3, 4). The total width of open cracks was approximately 95 cm.

Photo 3 Graben-like rupture in the Matoishi area (taken toward the northwest on May 11, 2016)

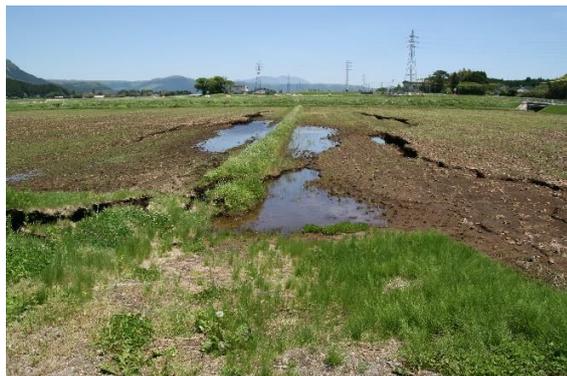
Photo 4 Graben-like rupture in the Matoishi area (taken toward the northeast on May 11, 2016)

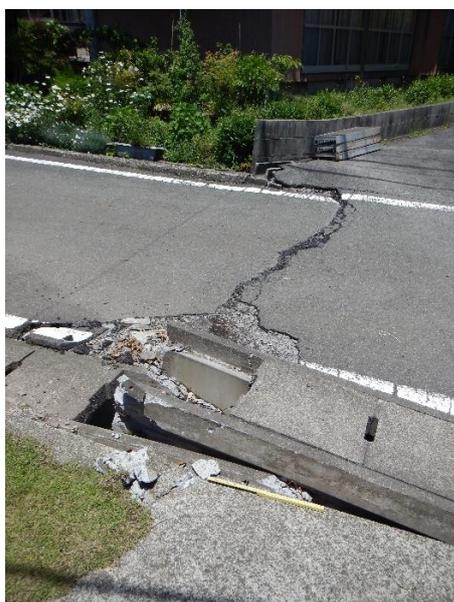
Around the northern edge of the horizontal displacement areas (Adogase, Aso City), a large number of shortening and open cracks perpendicular to the road were found on the road running north-northwest to south-southeast (Photo 5). The total shortening length of multiple shortening

cracks was approximately 130 cm.

Photo 5 Shortening deformation of the road and lateral gutter (taken toward the northeast on May 11, 2016). The lateral gutter was shortened approximately 20 cm.

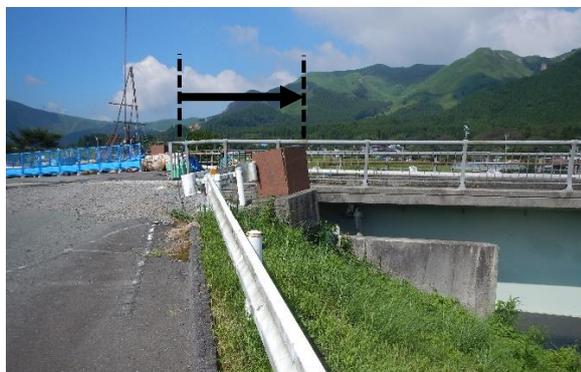
Also, at the Taisho Bridge over the Kurokawa River, the boundary between the bridge and embankment was greatly shortened with approximately 280 cm relatively towards the north (Photo 6). A bulge-like up-lift of the river bed can be identified on the aerial photo taken after the earthquake (Fig. 7). These damages were also reported by other organizations (e.g. JSEG 2016 Kumamoto-Oita Earthquake disaster investigation team (2016b)).

Photo 6 Shortening deformation of Taisho Bridge (taken toward the west-southwest on Aug. 15, 2016). Embankment was displaced approximately 280 cm relatively towards the north (right side of photo).

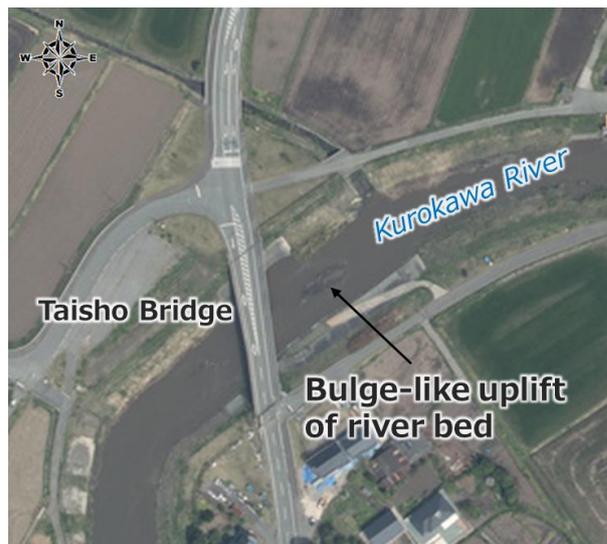
Fig. 7 Bulge-like uplift of Kurokawa River bed identified by aerial photo (taken on Apr. 16, 2016)

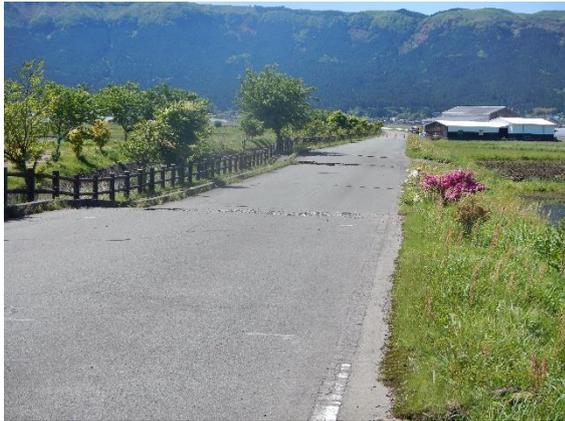
Figure 8 shows a close up image of the Uchinomaki area shown in Figure 3. At spots with graben-like ruptures located along the eastern edge of the interference fringe (Ozato/Yuyama, Aso City), a depression was identified between two major ruptures extending in the north-northeast to south-southwest direction (Photo 7). The vertical offset of the ruptures was approximately 50 cm with a side slip of approximately 5 cm.

Photo 7 Graben-like rupture at the Ozato/Yuyama area (taken toward the northwest on May 11, 2016)

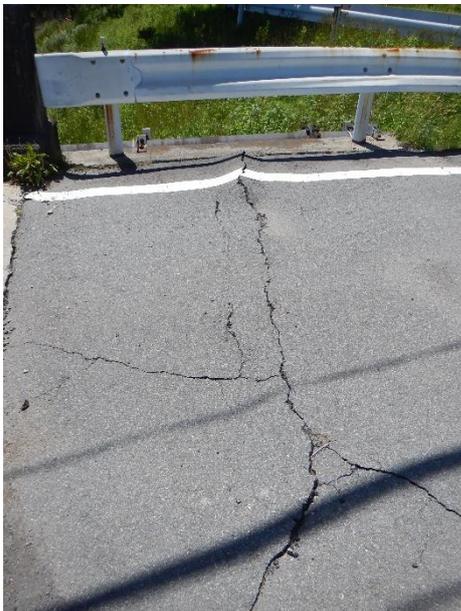
Around the northern and northwestern edge of horizontal displacement (Ozato/Nishikozono, Aso City), a large number of shortening cracks were identified on the roads and bridge around the junction of Yuura River and Kabaru River and roads around paddy fields located in marsh zones (Photos 8, 9). Shin-kabaru Bridge over the Yuura River was lifted up due to a shortening deformation (Photo 10).

Photo 8 Shortening cracks at the junction of Yuura River and Kabaru River (taken towards the west on May 11, 2016)

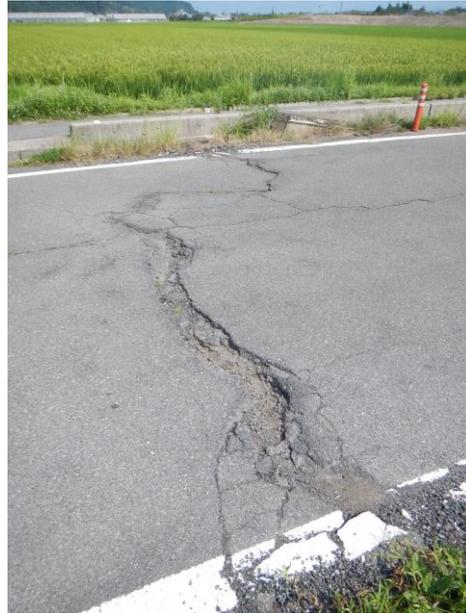
Photo 9 Shortening cracks of road and curbstone around paddy fields located in marsh zone (taken toward the east on May 11, 2016)

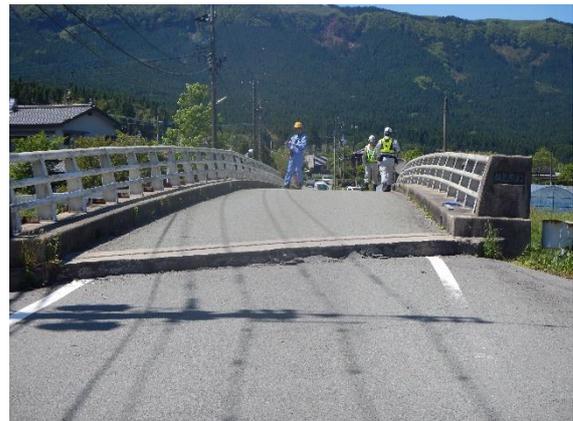
Photo 10 Uplifting of Shin-kabaru Bridge (taken toward the north on May 11, 2016)
