Geomorphological Features of Avalanche Furrows in Heavy Snow Region in Japan

Tatsuo SEKIGUCHI, Hiroshi P. SATO and Kazuya AKIYAMA¹

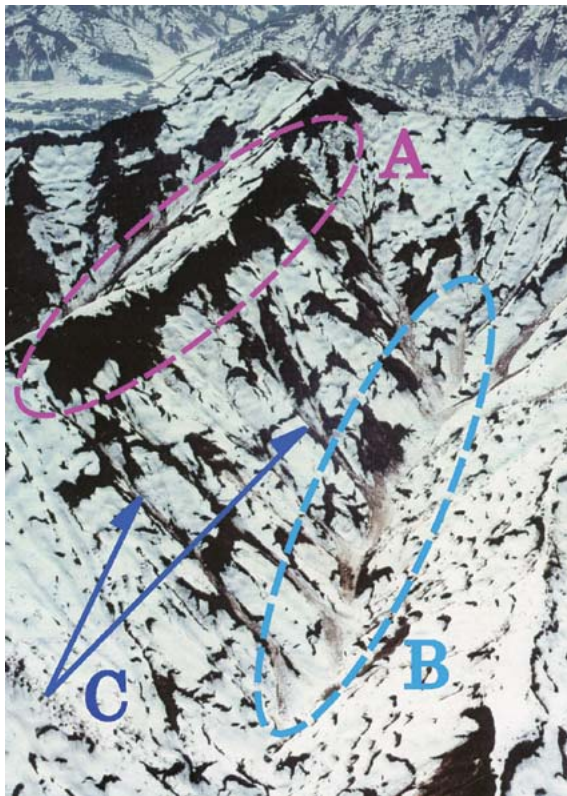
Fig. 2 Aerial photograph of slopes subjected to full-depth snow avalanches in Uonuma area. A : FDSA starting area B : avalanche deposit area C : avalanche furrow (March 1989, by the Geographical Survey Institute).

Figure 2 shows typical slopes subjected to

FDSAs. A FDSA starts near the top of a ridge, runs out on a slope and finally deposits at the foot of the slope as a snow-debris cone (Onodera, 1974). In Japan, FDSAs

occur on steep slopes during the snow melting period in spring, when air temperatures rise above 0°C. A FDSA is generated when the snow depth reaches more than 2 m on slopes covered mainly with shrubs. The collapsed snow mass gradually changes into fluid, flowing down the slope leaving the bedrock exposed. Many tree blocks, earth and sand are involved in the avalanche debris caused by FDSA (Fig. 3).

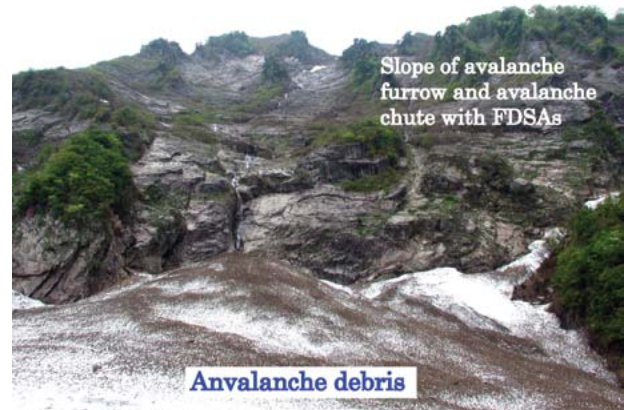
Fig. 3 Avalanche debris with FDSA in Mt. Gongendake (May 2003, by the authors).

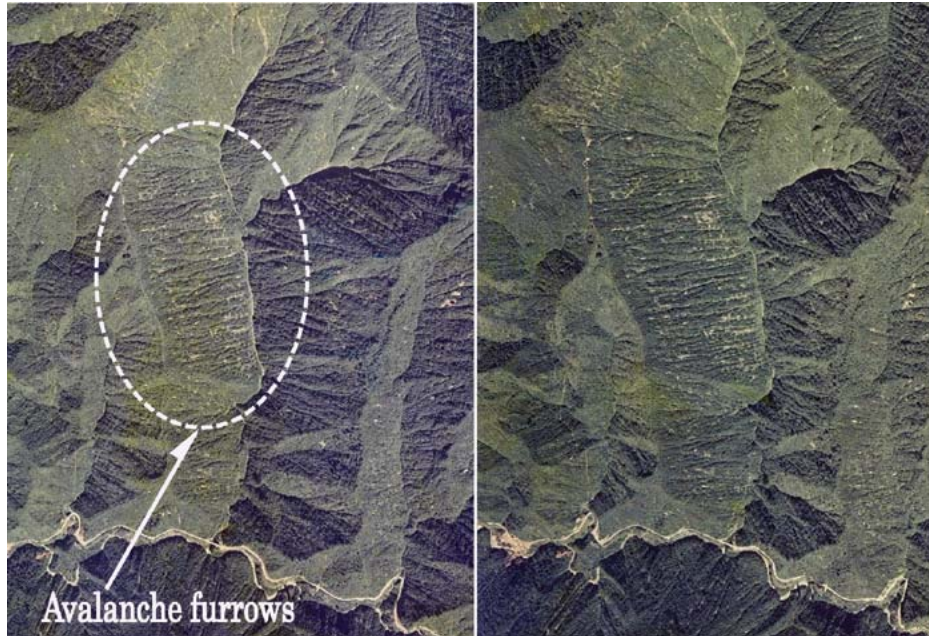
Fig. 4 Avalanche furrows in the Uonuma area; aerial photograph, taken during a snow-free period (September 1976, by the Geographical Survey Institute). Possible use stereo vision with 3D.

Avalanche furrows display straight scratched patterns on aerial photographs in snow-free periods (Fig. 4). Figure 5 shows a typical example of the FDSA-affected slopes. The bottom of a furrow usually exposes bedrock and both sides of the furrow are partly covered with grasses and shrubs. Avalanche furrows have a semicircular or U-shaped cross profile as if they had been formed by a round chisel, with a width of 2-4 m and a depth of 1-3 m (Fig. 6). The upper and middle parts of the avalanche furrows show very smooth surfaces with many striae produced by FDSAs. In the field, these striae have a length of 0.5-2 m, a width of 1-3 cm and a depth of 0.5-2 cm. These features indicate that erosion by FDSA is active, and that avalanche furrows are produced by FDSA.

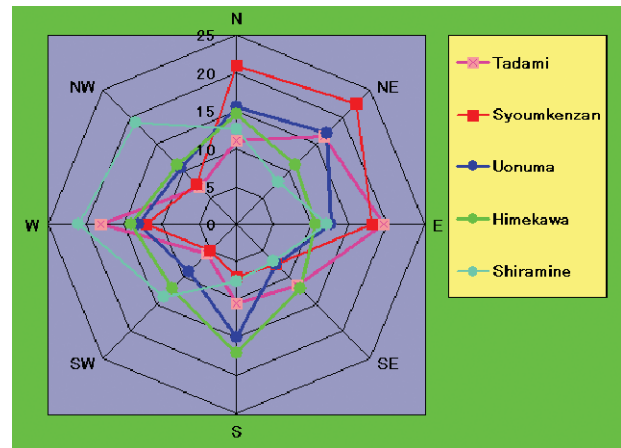
Fig. 8 Directions of avalanche furrows on slopes subject to full-depth snow avalanches locations are shown in Fig. 1.

Figure 8 shows directions of avalanche furrows in the Tadami, Shomenzan and the three sample areas. Data are based on aerial photographs either in snow avalanche periods (the three sample areas) or in snow-free periods (the other two areas). The prevailing directions are to the west and south in the three sample areas. Avalanche furrows are rarely seen on the north and northeast-facing slopes of shaded parts where most of the FDSAs may occur at a later period. In fact, aerial photographs in these sample areas taken during the period of FDSA occurrence indicate that FDSAs most frequently occurred on the west and south slopes. Thus, data from these three areas may not show the actual prevailing directions. In contrast, the prevailing directions are east to northeast in Tadami and Shomenzan areas where avalanche furrows could be seen over all directions as they were mapped from aerial photographs in the snow-free period.

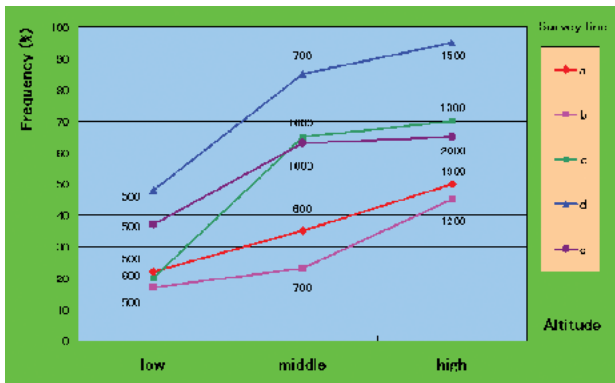
Fig. 11 Relationship between the occurrence of avalanche furrows and altitude. The survey lines are shown in Fig.10. a : Hokkaido, b : Northern Tohoku c : Southern Tohoku d : Eastern Hokuriku e : Western Hokuriku. The altitudes are classified into mountains of low, middle and high for each survey line. The representative altitudes (m) for the classes are indicated.

Figure 11 shows changes in the occurrence frequency of avalanche furrows with altitude along the survey lines drawn in Fig. 10. The survey lines show transverse profiles from the Japan Sea coast toward the Pacific coast in five regions. Along each line, mountains were classified in terms of altitude as low (approx, 500m), middle (approx, 1000m) or high (approx, 2000m), in which the numbers stand for the altitude of each region and each survey line.

In Hokkaido and the northern Tohoku regions, the frequency is only 20 % on the low mountains and 50 % on the high mountains, but it increases to 70 % on the middle and high mountains in the southern Tohoku and western Hokuriku regions. The frequency is highest over all elevations in the eastern Hokuriku region, reaching 85-95 % on the high mountains. Therefore, the occurrence frequency generally increases with altitude and is highest in the Hokuriku region.

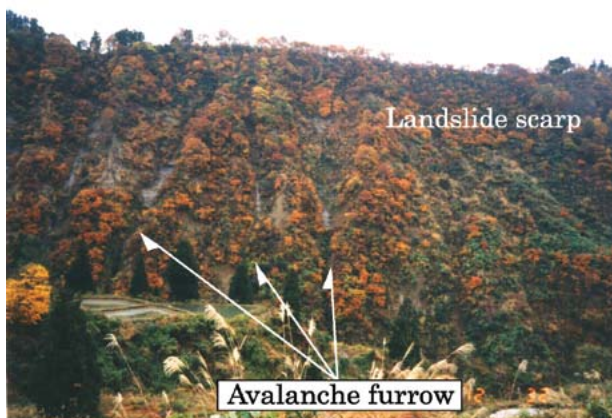
Fig. 13 View of avalanche furrows on landslide scarp in Uonuma area (November 1985, by the authors).

factor of the avalanche furrow formation. Slopes with avalanche furrows occur mostly on mountain sides. Sekiguchi & Sugiyama (2003) reported avalanche furrows occur also on landslide scarps, river terrace scarps, caldera walls and glacial cirques (Fig. 12 ; Fig. 13). All of these landforms have steep slopes. Avalanche

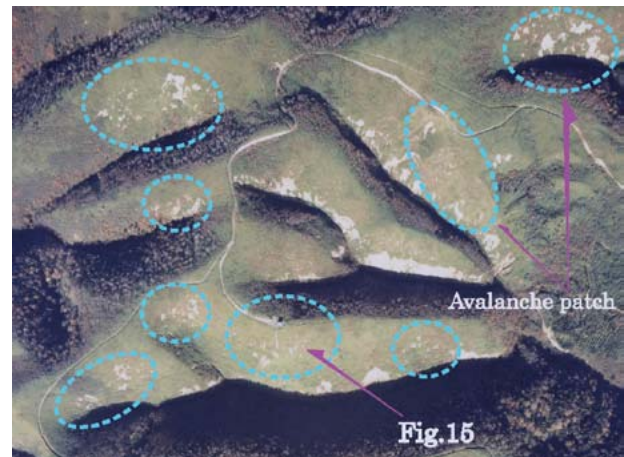
Fig. 14 Avalanche patch on slope with full-depth snow avalanche in Toikanbetsu area, Hokkaido (October 1977, by the Geographical Survey Institute).

Slopes with FDSAs have avalanche patches in addition to avalanche chutes and avalanche furrows (Sekiguchi et al., 2003). Avalanche patches rarely exist in the upper and middle parts of the slopes with FDSAs. Figure 14 shows typical avalanche patches in Toikanbetsu area, Hokkaido. They are mostly elliptic shapes, with a width of several meters, a longitudinal length of 5-10 m and a depth of 10-30 cm (Fig. 15). On the inside of the patches are, in many cases, exposed soil and bedrock. The inclination of slopes with avalanche patches is gentler than those showing avalanche furrows, which suggests that the strength of the erosion by FDSAs is smaller in avalanche patches than avalanche furrows.

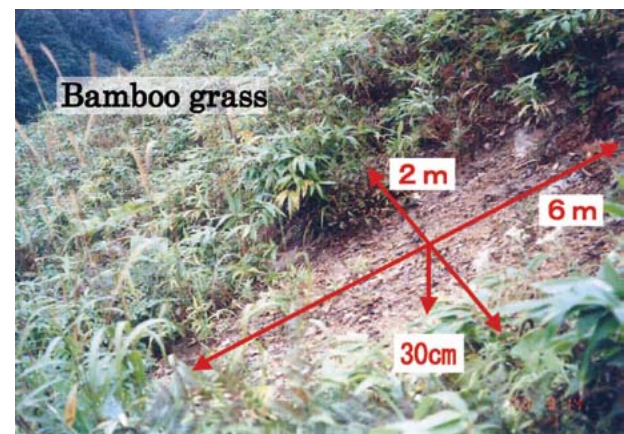
Fig. 15 Ground surface of avalanche patch in Toikanbetsu area (September 2000, by Imanishi N., Hokkaido university).

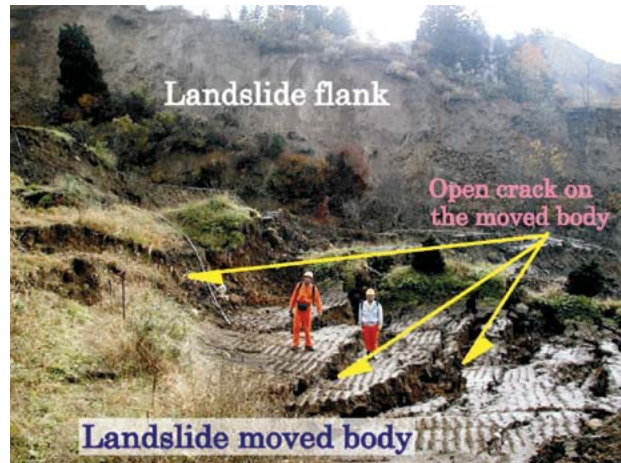
Fig. 19 Landslide in Terano area caused by 2004 Mid Niigata Earthquake (November 2004 by authors)

The Mid Niigata Prefecture Earthquake occurred on November 23rd, 2004, and caused a large number of simultaneously disasters such as slope failures, landslides, damming up many of the rivers. Roads and houses were also destroyed (Fig. 19). These regions are mountainous (300-400 m) and the prevalent geology is dominated by sand and Tertiary clay deposits. This has caused many landslides. The region has heavy snowfall reaching a snow-depth of 2-3 m every winter where many avalanche furrows are seen on the mountain sides and landslide scarps. Many slope failures and landslides caused by the Mid-Niigata Earthquake are steep slopes
