Field Survey of Non-tectonic Surface Displacements Caused by the 2016 Kumamoto Earthquake Around Aso Valley

Takayuki NAKANO, Tomokazu KOBAYASHI, Kazuki YOSHIDA and Satoshi FUJIWARA

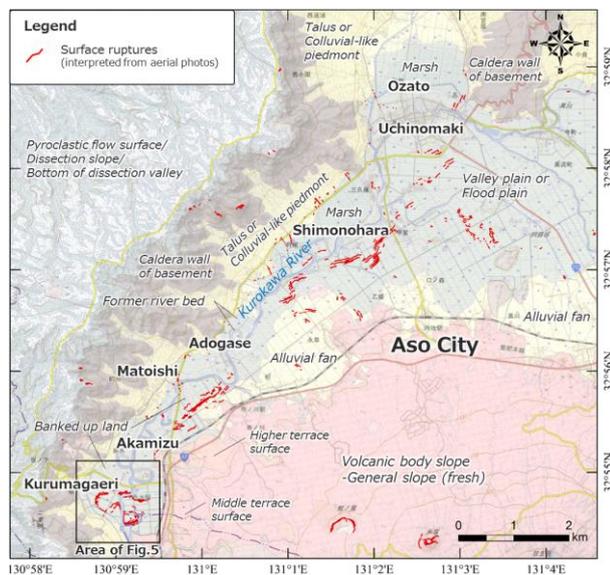
In this area, clear surface ruptures were identified from the Kurumagaeri area to Uchinomaki area, Aso City. The surface ruptures are arranged linearly or in a meandering pattern, and as a whole are arranged in north-east to south-west direction.

Stereoscopic vision interpretation of aerial photos made it possible to confirm that the ground between some major parallel surface ruptures collapsed in graben-like shapes around the Matoishi area and the Shimonohara area, Aso City.

Fig. 2 Distribution map of surface ruptures as identified from aerial photos taken in the study area. GSI Maps and the 1:30,000 scale land condition map of volcano “Mt. Aso” are used as the background map.

Also, as the shape of the meandering surface ruptures in the Kurumagaeri area matches the shape of the banked-up land of the former river bed, it is presumed that these meandering surface ruptures were caused by ground subsidence associated with ground liquefaction of former river bed. However, the relationship between location of surface ruptures and landform does not always match in other areas.

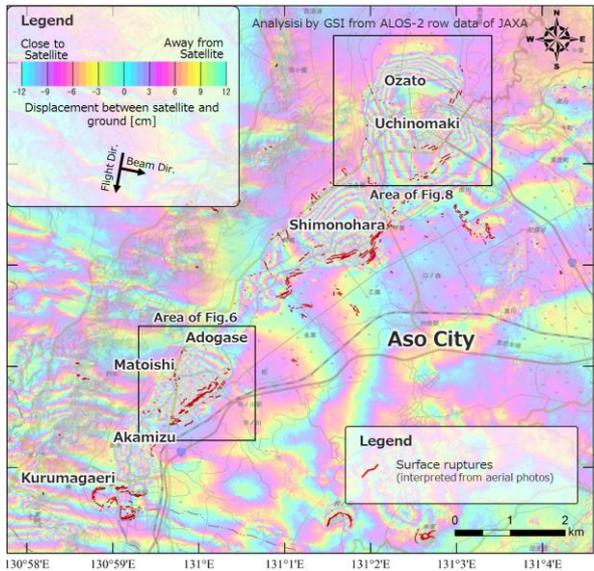
A non-interference zone approximately 1.3km in diameter can be identified in the Matoishi area. Around Shimonohara area, there is a mixture of non-interference zones and interference fringes in the range of approximately 2 km from east-to-west and approximately 1.3 km from south-to-north. The diameter of this interference fringe zone is approximately 2.5 km around the Uchinomaki area. According to Fujiwara et al. (2016a), surface deformations can be observed in these areas having a horizontal displacement of more than 2m in a north-northwest direction.

Many surface ruptures are distributed around the southeastern periphery of these surface displacements. Also, GSI (2016b) suggests that these surface displacements have almost no vertical component and displace mostly horizontally toward the caldera wall (Fig. 4). These features are also clarified by the differential analysis between pre- and post-earthquake digital elevation model (DEM) produced by airborne laser survey (JSEG 2016 Kumamoto-Oita Earthquake disaster investigation team, 2016a). In comparison with landform classification of Figure 2, the surface displacements in the Shimonohara area and Uchinomaki area seem to move toward the marsh zone.

The SAR interferograms indicate that these surface displacements only occur within certain areas and do not occur in other areas. This phenomenon suggests that large-scale surface displacements were located in extremely shallow zones (Fujiwara et al., 2016a).

Fig. 3 Surface ruptures distribution and representative SAR interferogram by ALOS-2 data (Apr. 15, 2016-Apr. 29, 2016) of study area

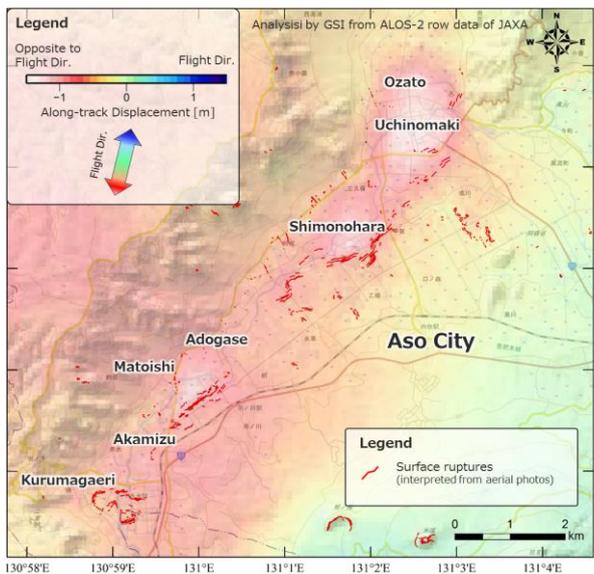
Fig. 4 Surface displacement map around the study area as revealed by MAI (Multiple Aperture Interferometry) analysis (modified from GSI (2016b)). MAI is a technique for measuring ground displacement along flight direction of the satellite (azimuth offset) using two SAR images.

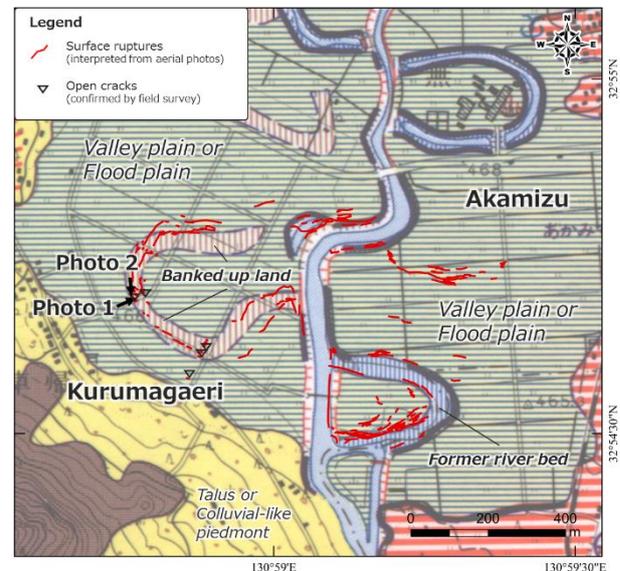
Figure 5 shows a close up figure of the Kurumagaeri area shown in the Figure 2. In this area, graben-like ruptures were confirmed along former river bed. Major ruptures cross a paddy field surface and a road, which matches the result of aerial photos interpretation (Photo 1), and the portion of the road between two ruptures subsided approximately 30 cm (Photo 2).

Fig. 5 Distribution map of surface ruptures around Kurumagaeri (The 1:30,000 scale land condition map of volcano “Mt. Aso” is used as the background map)

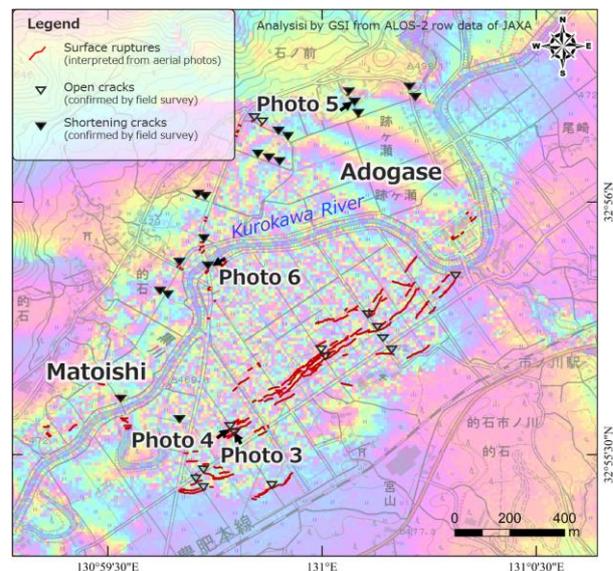
Figure 6 shows a close up image of the Matoishi area as shown in the Figure 3. At spots with graben-like ruptures located along the southern edge of the horizontal displacement areas as detected by SAR interferogram, there were open cracks with vertical offsets of up to 70 cm (Photos 3, 4). The total width of open cracks was approximately 95 cm.

Around the northern edge of the horizontal displacement areas (Adogase, Aso City), a large number of shortening and open cracks perpendicular to the road were found on the road running north-northwest to south-southeast (Photo 5). The total shortening length of multiple shortening

Also, at the Taisho Bridge over the Kurokawa River, the boundary between the bridge and embankment was greatly shortened with approximately 280 cm relatively towards the north (Photo 6). A bulge-like up-lift of the river bed can be identified on the aerial photo taken after the earthquake (Fig. 7). These damages were also reported by other organizations (e.g. JSEG 2016 Kumamoto-Oita Earthquake disaster investigation team (2016b)).

Fig. 6 Overlay of ruptures distribution and field surveyed-cracks on the SAR interferogram (Apr. 15, 2016-Apr. 29, 2016) around the Matoishi area

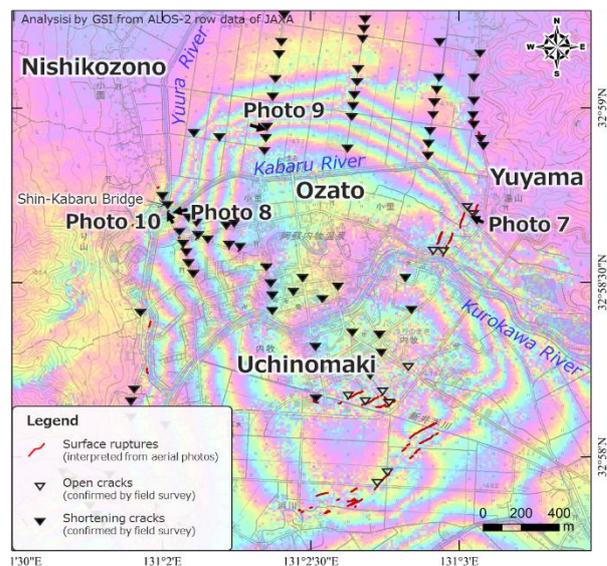
Figure 8 shows a close up image of the Uchinomaki area shown in Figure 3. At spots with graben-like ruptures located along the eastern edge of the interference fringe (Ozato/Yuyama, Aso City), a depression was identified between two major ruptures extending in the north-northeast to south-southwest direction (Photo 7). The vertical offset of the ruptures was approximately 50 cm with a side slip of approximately 5 cm.

Fig. 8 Overlay of the surface ruptures and field surveyed-cracks on the SAR interferogram (Apr. 15, 2016-Apr. 29, 2016) around the Uchinomaki area

Around the northern and northwestern edge of horizontal displacement (Ozato/Nishikozono, Aso City), a large number of shortening cracks were identified on the roads and bridge around the junction of Yuura River and Kabaru River and roads around paddy fields located in marsh zones (Photos 8, 9). Shin-kabaru Bridge over the Yuura River was lifted up due to a shortening deformation (Photo 10).
